**Re: Wetland Delineation and RPA Determination**  
9841 Fairview Rd  
GPIN: 7270-03-8136  
Spotsylvania County

## Stream Photo Log

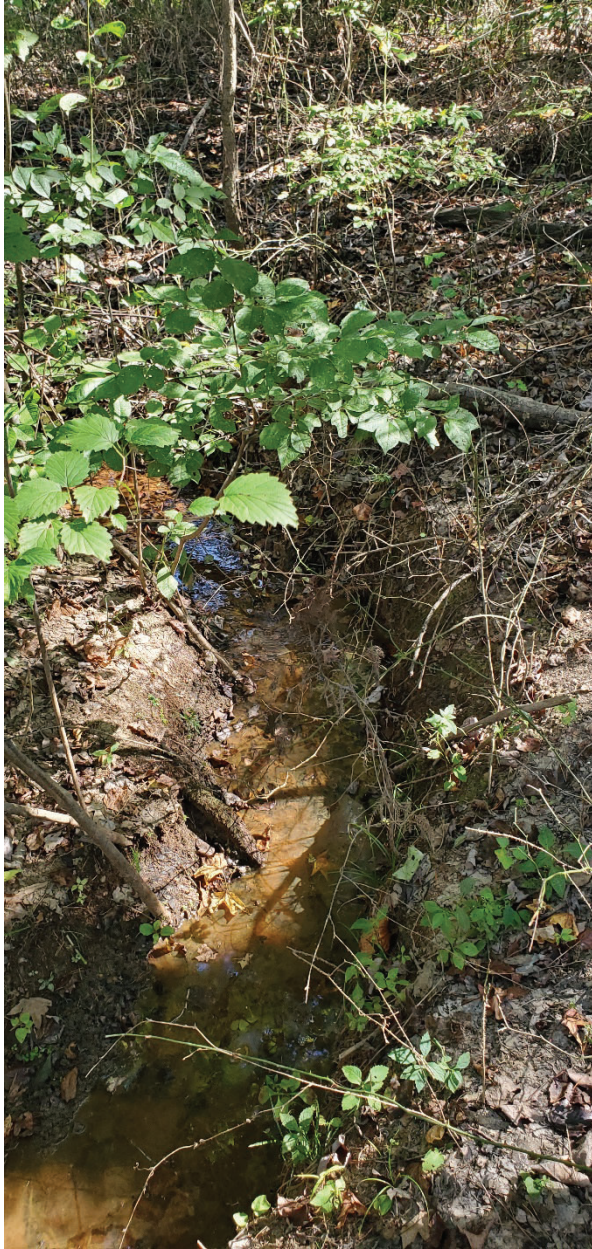
Photo 1: I-2 viewing upstream

| <b>Total Points:</b><br><i>Stream is at least intermittent if <math>\geq 19</math> or perennial if <math>\geq 30</math>*</i> | <b>Stream Determination (check one)</b><br>Ephemeral <input type="radio"/> Intermittent <input checked="" type="radio"/> Perennial <input type="radio"/> | <b>Other</b><br><i>e.g. Quad Name:</i> |

28.25

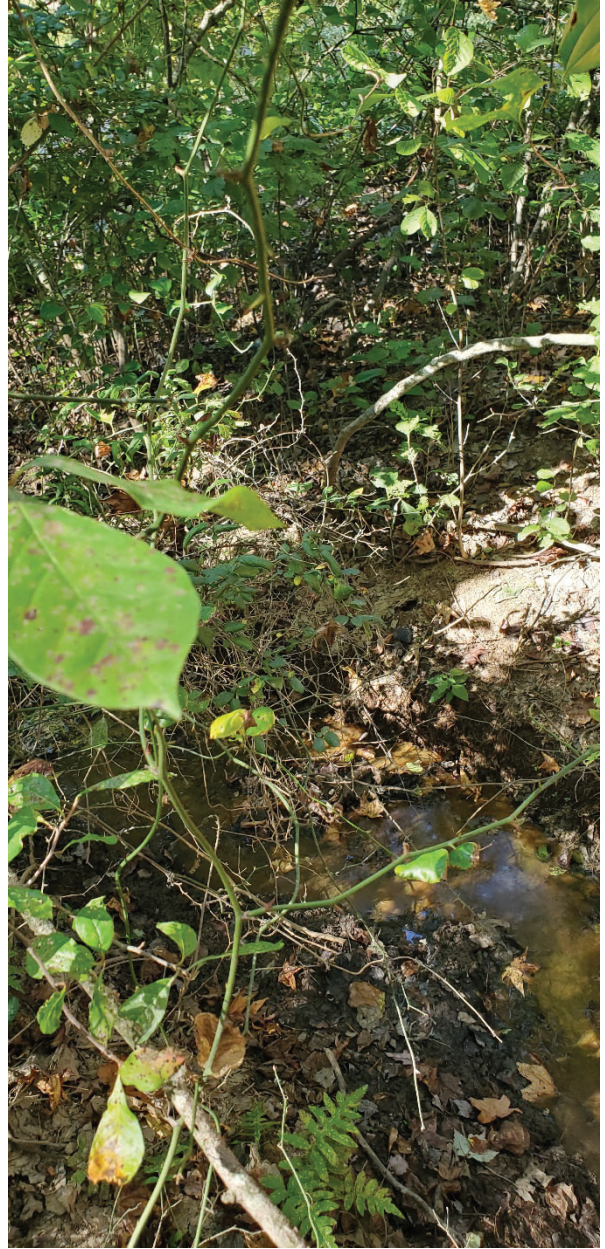
Photo 2: I-2 viewing downstream

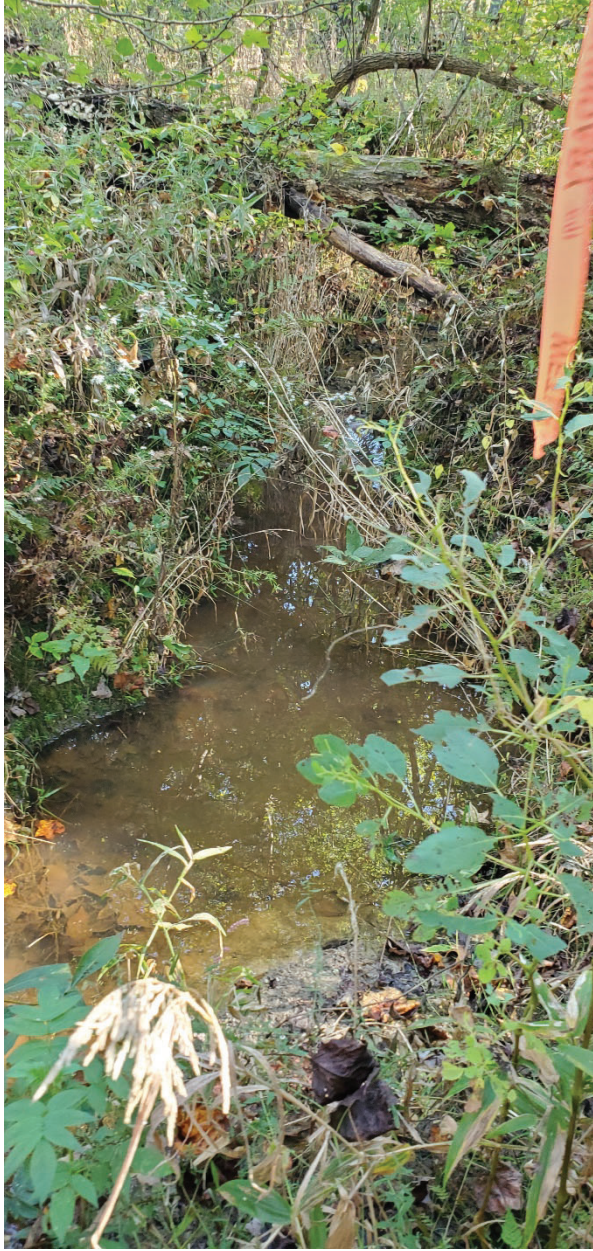
Photo 3: IB-2 viewing upstream

| <b>Total Points:</b><br><i>Stream is at least intermittent if <math>\geq 19</math> or perennial if <math>\geq 30</math>*</i> | <b>Stream Determination (check one)</b><br>Ephemeral <input type="radio"/> Intermittent <input checked="" type="radio"/> Perennial <input type="radio"/> | <b>Other</b><br>e.g. Quad Name: |

27.25

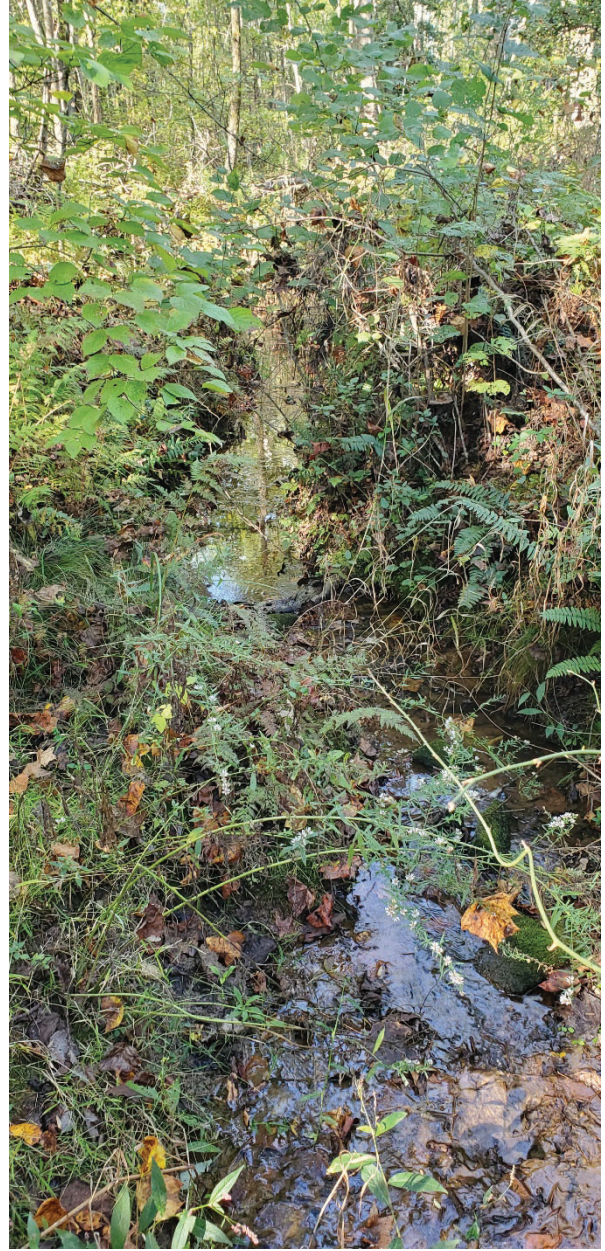
Photo 4: IB-2 viewing downstream

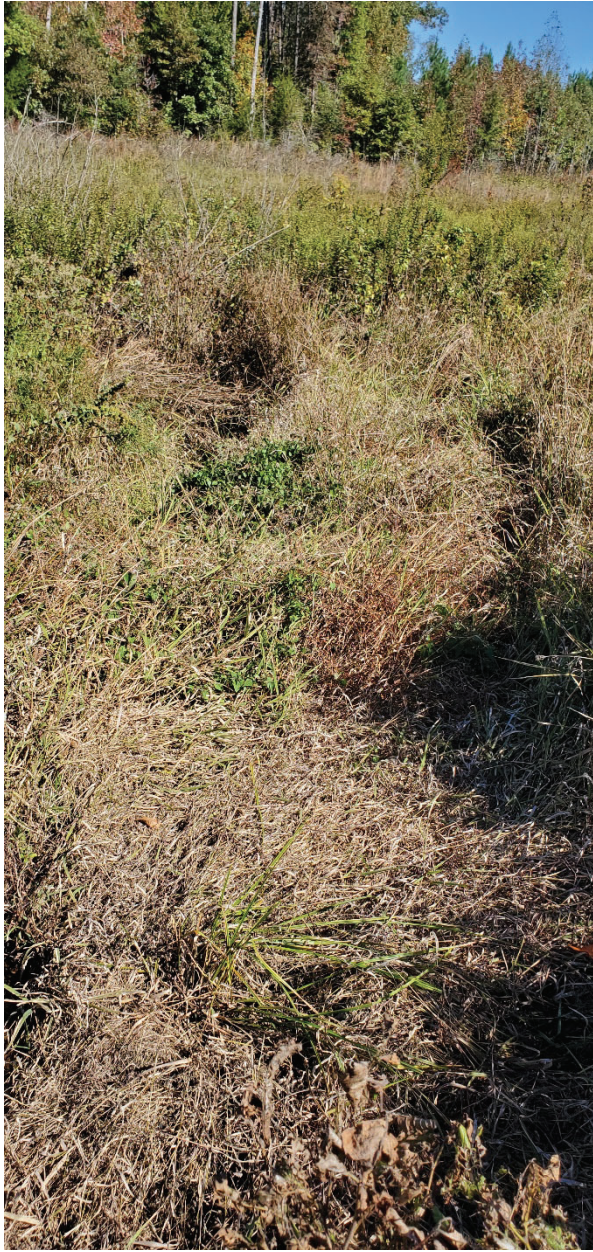
Photo 5: WEB-26 viewing upstream

| <b>Total Points:</b><br><i>Stream is at least intermittent if <math>\geq 19</math> or perennial if <math>\geq 30</math>*</i> | <b>Stream Determination (check one)</b><br>Ephemeral <input type="radio"/> Intermittent <input checked="" type="radio"/> Perennial <input type="radio"/> | <b>Other</b><br>e.g. Quad Name: |

21.75

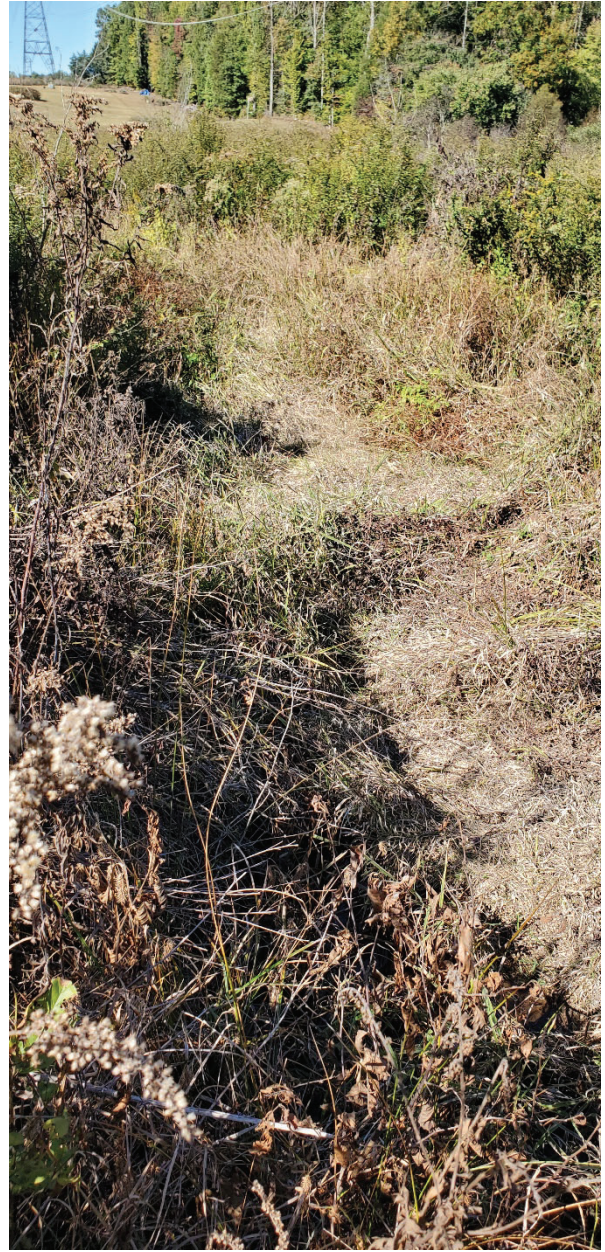
Photo 6: WEB-26 viewing downstream

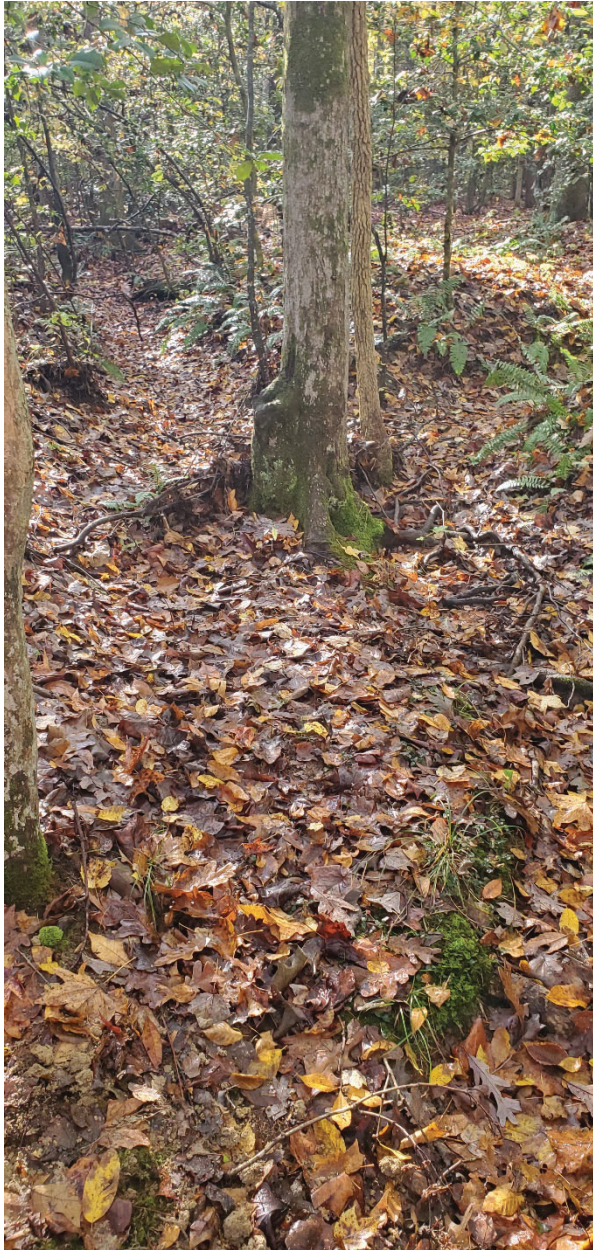
Photo 7: EF-9 viewing upstream

| <b>Total Points:</b><br><i>Stream is at least intermittent if <math>\geq 19</math> or perennial if <math>\geq 30</math>*</i> | <b>Stream Determination (check one)</b><br><input checked="" type="checkbox"/> <b>Ephemeral</b> <input type="checkbox"/> <b>Intermittent</b> <input type="checkbox"/> <b>Perennial</b> | <b>Other</b><br><i>e.g. Quad Name:</i> |

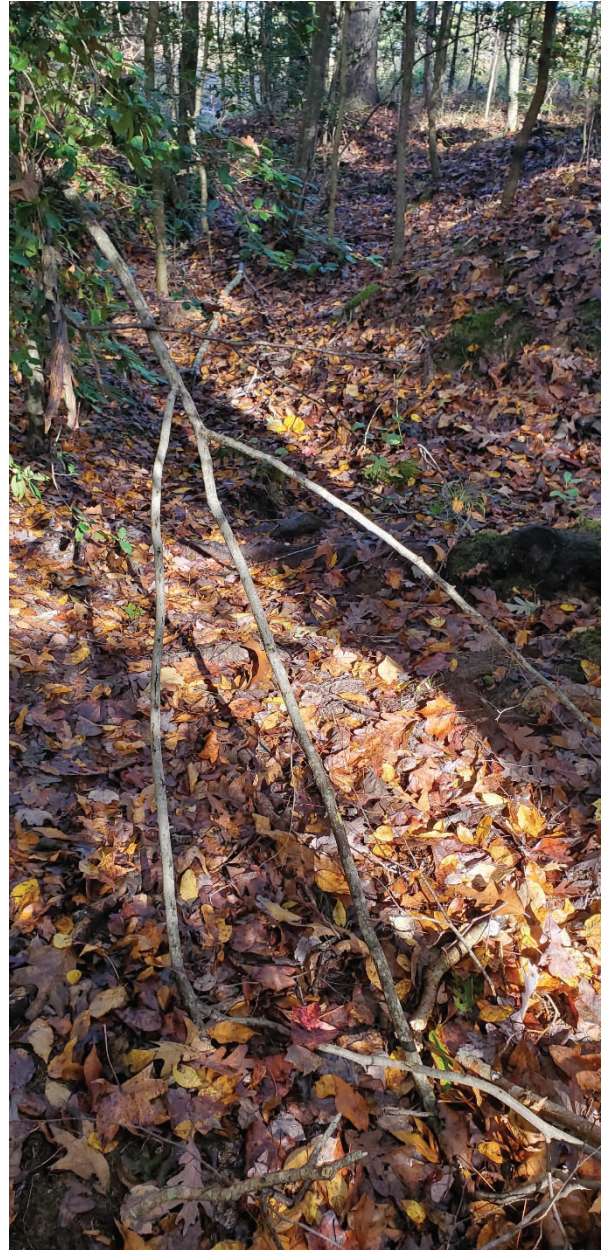
Photo 8: EF-9 viewing downstream
