TABLE OF CONTENTS

Subject Property: Vacant Forested Land
Block 601, Lots 44 and 45
Cooper Road and Lelache Avenue
Atco, New Jersey

RJS Environmental LLC (RJS) conducted a Phase I Environmental Site Assessment of the subject property in accordance with the scope and limitations of ASTM Practice E-1527-13. The following is a summary of findings.

RJS Environmental LLC (RJS) was contracted by Town Square Communities LLC to conduct a Phase I Environmental Site Assessment of a property located in the Atco section of Waterford Township, Camden County, New Jersey.

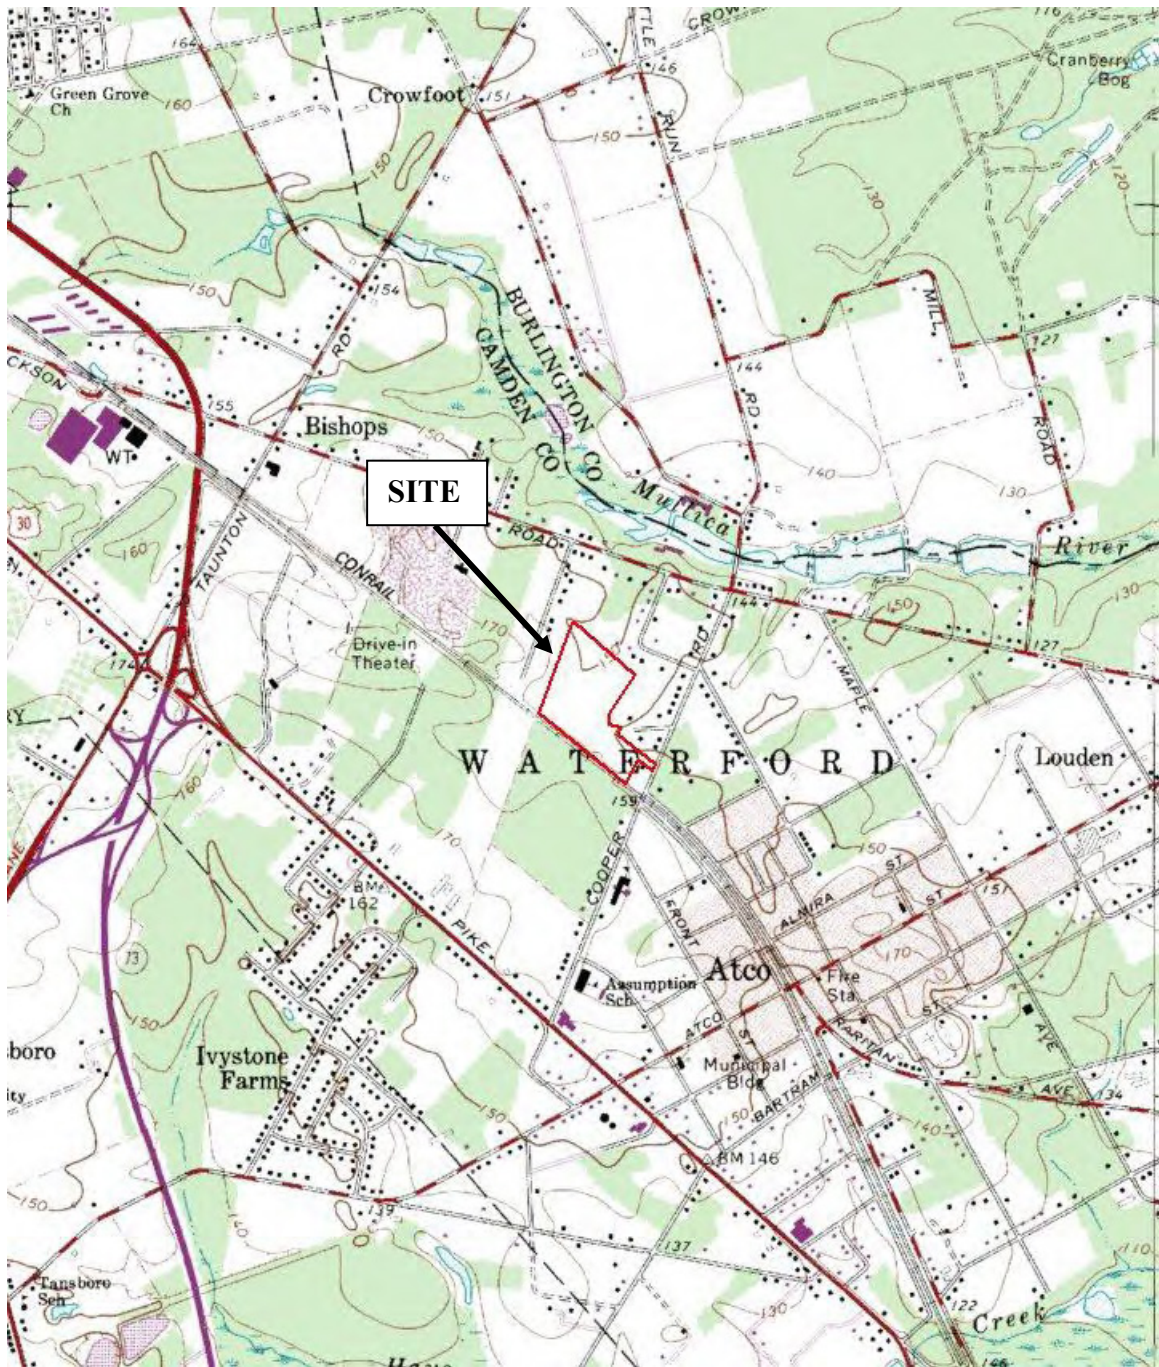
FIGURE 1.0:
USGS Topographic Map

The location of the subject property is depicted in Figure 1.0 - Regional Site Location Map¹ and in Figure 2.0 – Regional Aerial Photograph. A copy of a portion of a Waterford Township Tax Map² that includes the subject property is provided as Figure 3.0.

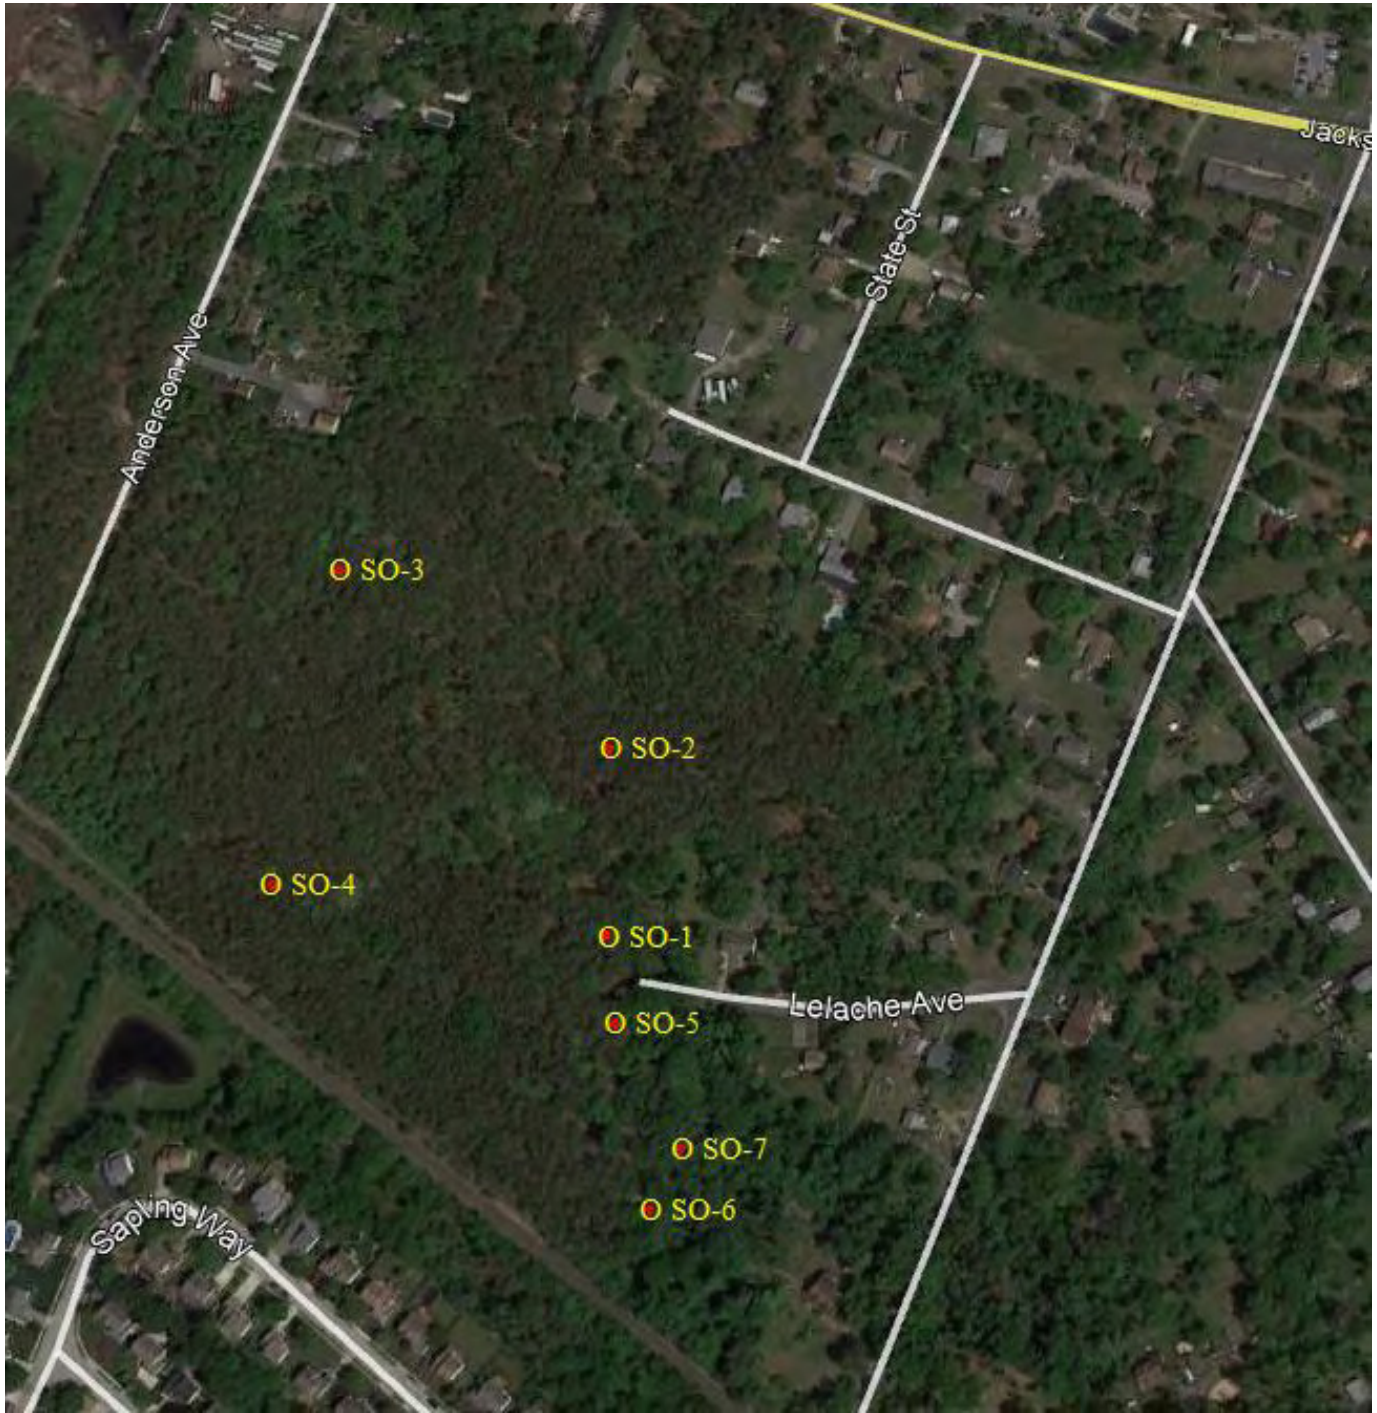
FIGURE 4.0:
Soil Sample Location Diagram

The review of historical aerial photographs indicated that the majority of the property (about 20 acres) had been historically used for agricultural purposes from at least 1931 until about the 1940s. On April 3, 2019 RJS collected a total of 7 representative surficial (0-6 inches) soil samples throughout the former agricultural use areas of the property. Soil samples were collected with dedicated stainless steel scoops and submitted to ALS Environmental Laboratory (NJDEP Certification No. PA010) in Middletown, PA for analysis. Soil sample locations were field staked and identified by coordinates obtained by use of a handheld GPS unit with the approximate locations shown in Figure 4.0. The analyses included pesticides by EPA Method 8081B and total arsenic/total lead by EPA Method 6010C. The analytical results are summarized in Table 2.0 below and a copy of the laboratory's analytical testreport (No. 3026272) is included as Appendix F.

The analytical results in Table 2.0 revealed no detectable concentrations of any pesticide compounds. All of the arsenic concentrations were trace level and lead concentrations were low. The concentrations reported for lead and arsenic were probably indicative of naturally occurring concentrations in the soils of the property. All reported concentrations for lead and arsenic were well below the applicable NJDEP Soil Remediation Standards. Based on these sampling and analytical results, no further investigation is necessary.
